**Re: Response to EPA Analysis of the *Final Habitat Mitigation and Monitoring Plan*, dated September 12, 2017, EPA Comments October 5, 2017 (Revised November 30, 2017)  
Rosemont Copper Project, Clean Water Act Section 404 Permit, CoE File No.: 2008-00816-MB**

**Rosemont – Response to EPA HMMP Comments**

**"The Mitigation Proposed by Rosemont Mine  
Will Not Offset Impacts to Waters of the U.S.  
below the Level of Significant Degradation"**

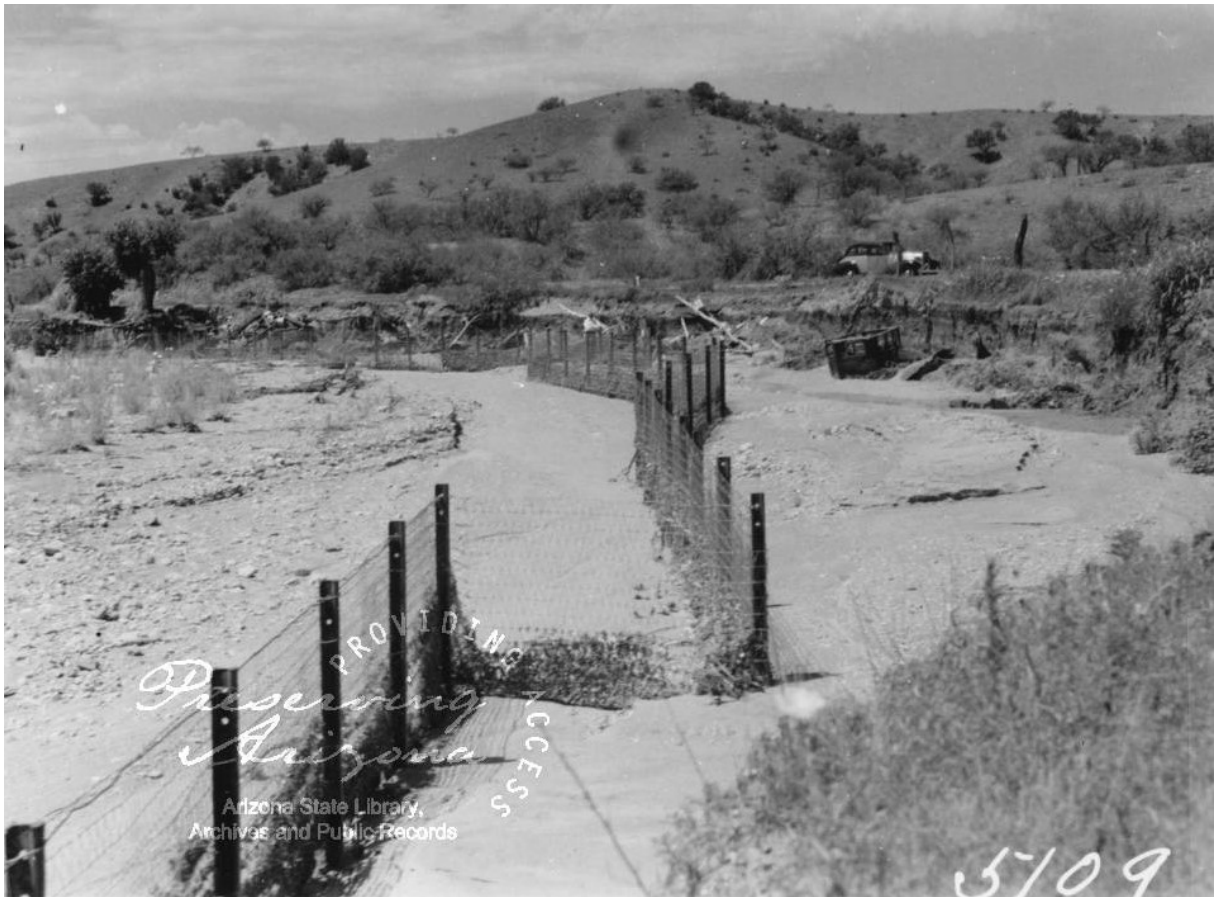
**Photo 1. Late 1930s View of Erosion Control Works along Sonoita Creek in the Vicinity of Rail-X Ranch**

As described previously, Anglo-American water management policies and practices lead to widespread downcutting along the Santa Cruz River, and there is evidence that similar changes had occurred along Sonoita Creek by the 1930s. A photograph believed to have been taken in the late 1930s in the vicinity of Rail-X Ranch shows that the stream had downcut and become incised by this point, and work was underway to construct gabions to reduce further erosion and protect State Route 82 (SR 82) (**Photo 1**). This shows that at least 60 years of Hispanic and Anglo-American water management practices had created an incised stream along this stretch of Sonoita Creek.

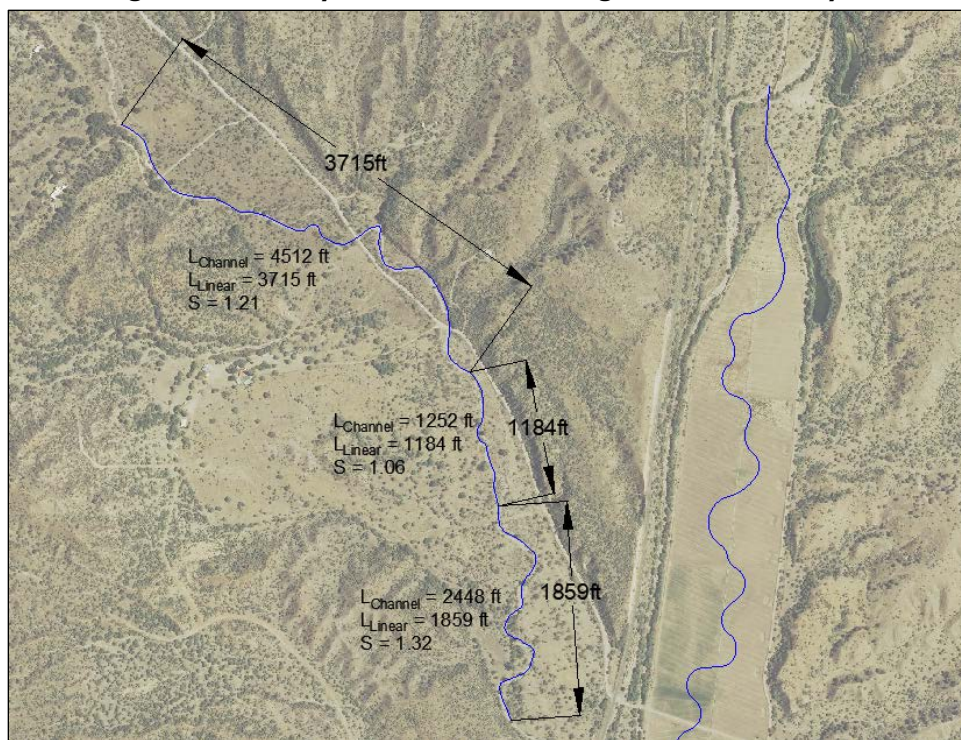
**Figure 7. Sinuosity Measurements on Big Casa Blanca Canyon**

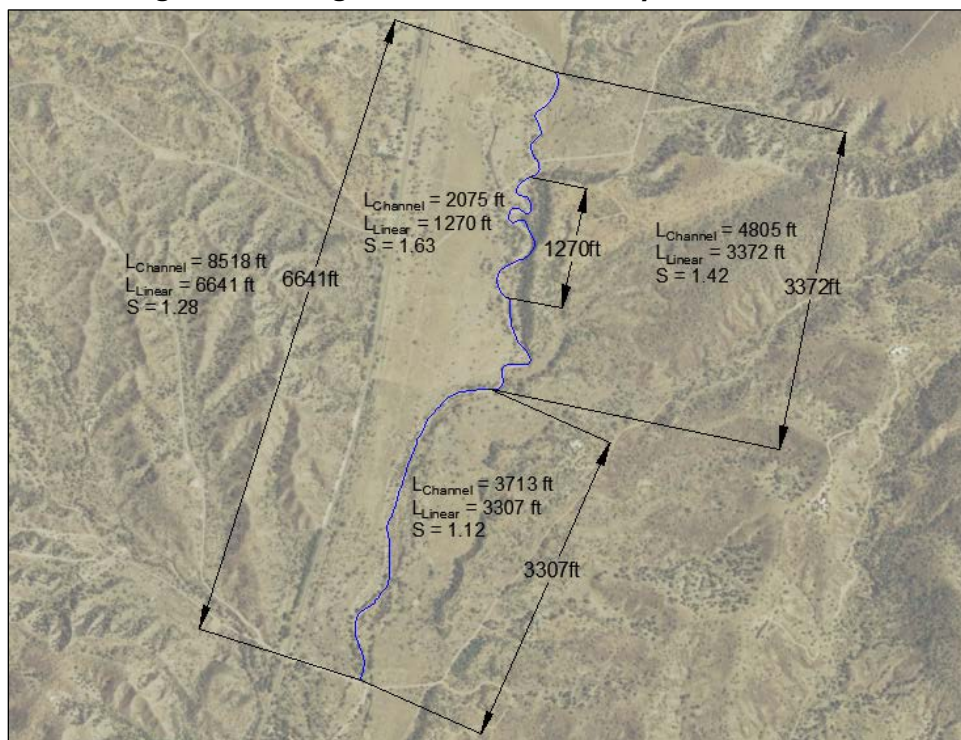
**Figure 8. Existing Sonoita Creek Sinuosity Measurements**

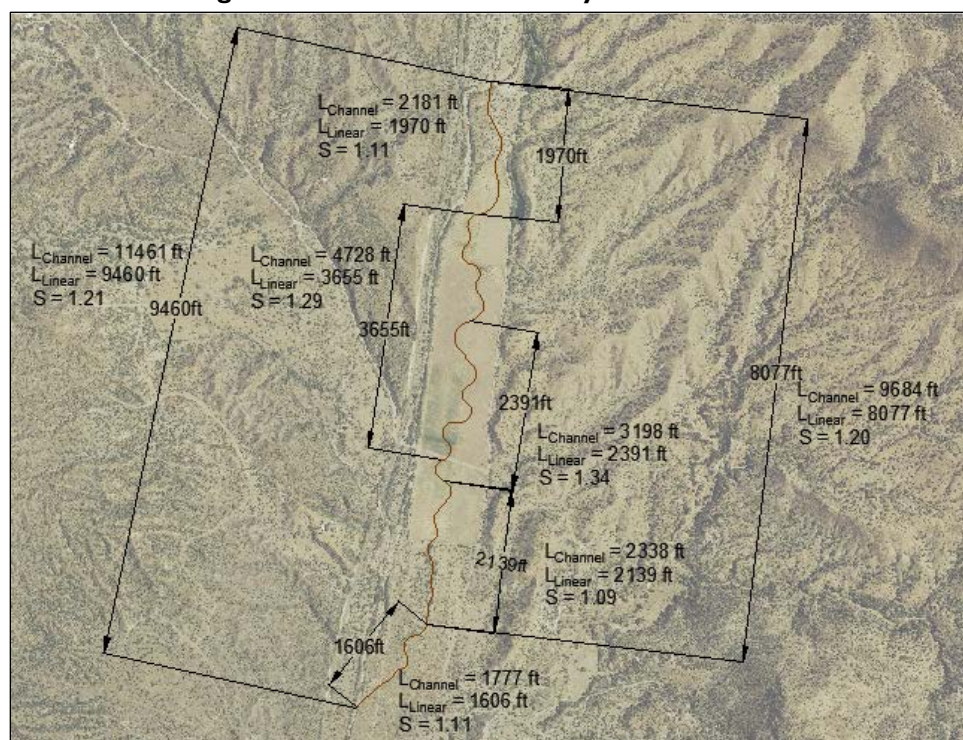
**Figure 9. SCR Channel Sinuosity Measurements**

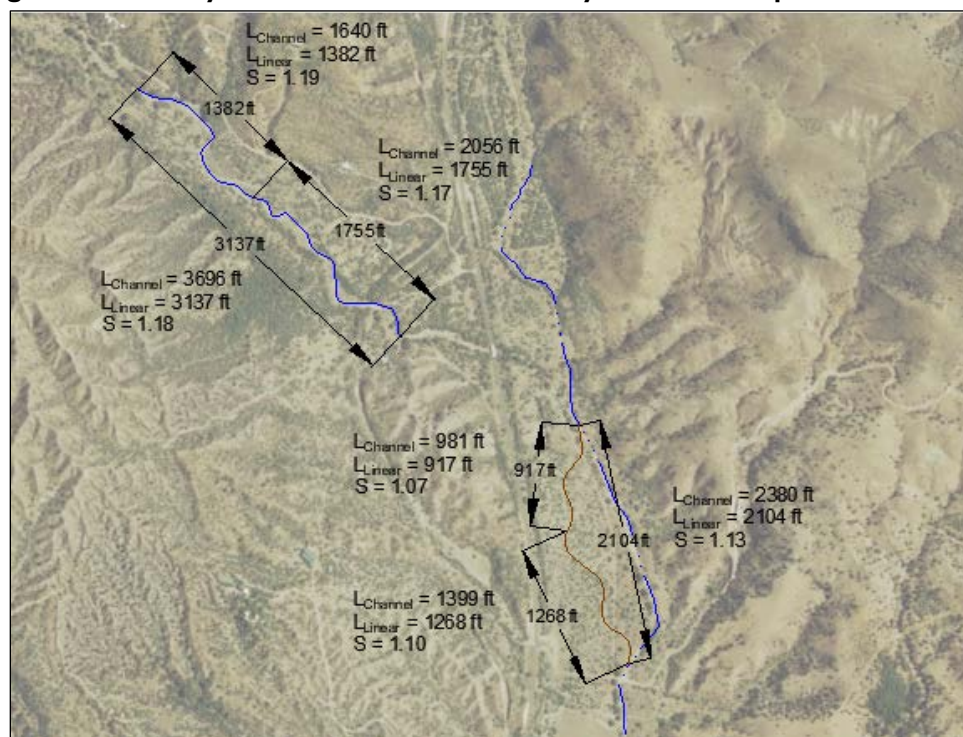
**Figure 10. Sinuosity Measurements on Adobe Canyon and the Proposed RX Channel**

Another point in need of clarification is that the proposed channels are designed with compound form, including the dominant channel shape, and an active channel nested inside the overall channel form. Thus, the sinuosity for the inundated water surface (during a 5-year storm) is related to, but different than, the sinuosity of the active channel nested within the dominant channel. The dominant sinuosity corresponds to sinuosity of the centerline of flood inundation during the 5-year storm event. Both the RX and SCR channels are designed with compound channel geometry that includes floodplain benches that vary in width through the channel bends. For instance, on the inside of a bend, the floodplain bench width increases, and on an outside bend, the floodplain bench width decreases. The effect is that significant storm events with a flow depth greater than 2-feet deep will have a straighter, less sinuous flow path (**Figure 10**).

In response, we note that the sinuosity measured at Adobe Canyon is slightly higher than the proposed sinuosity of the RX Channel (**Figure 10**). EPA's sinuosity analysis included portions of Walnut Gulch between Flume 6 and Flume 2. However, it is inappropriate to include these portions of Walnut Gulch as reference reaches, as they are physically constrained and confined by local geology/topography and

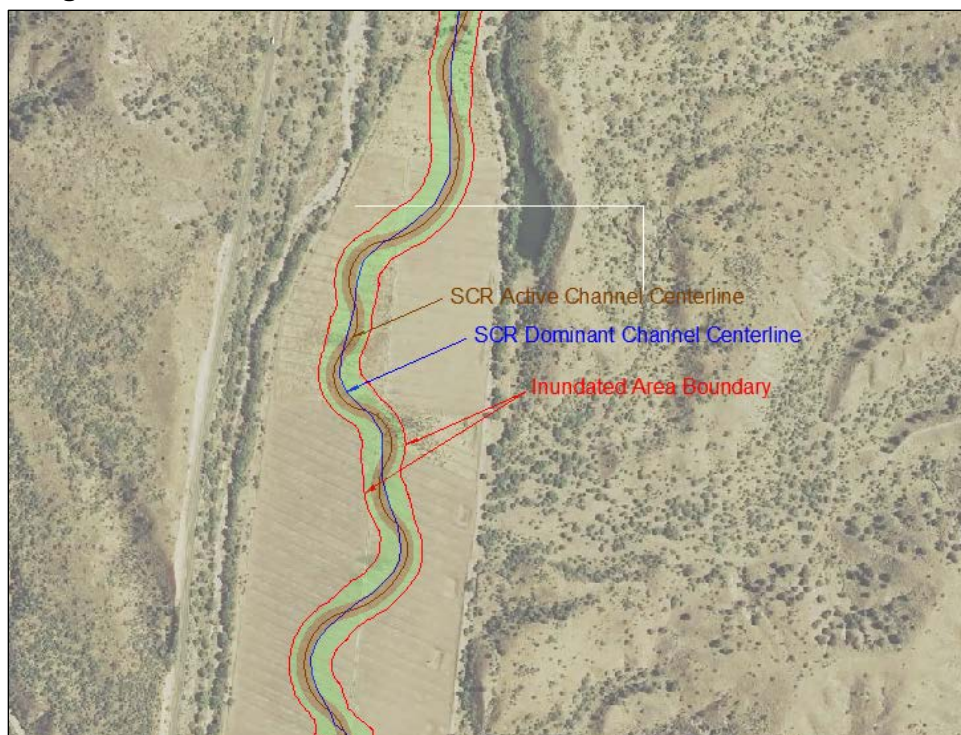
**Figure 11. Dominant Channel Centerline and Active Channel Centerline**

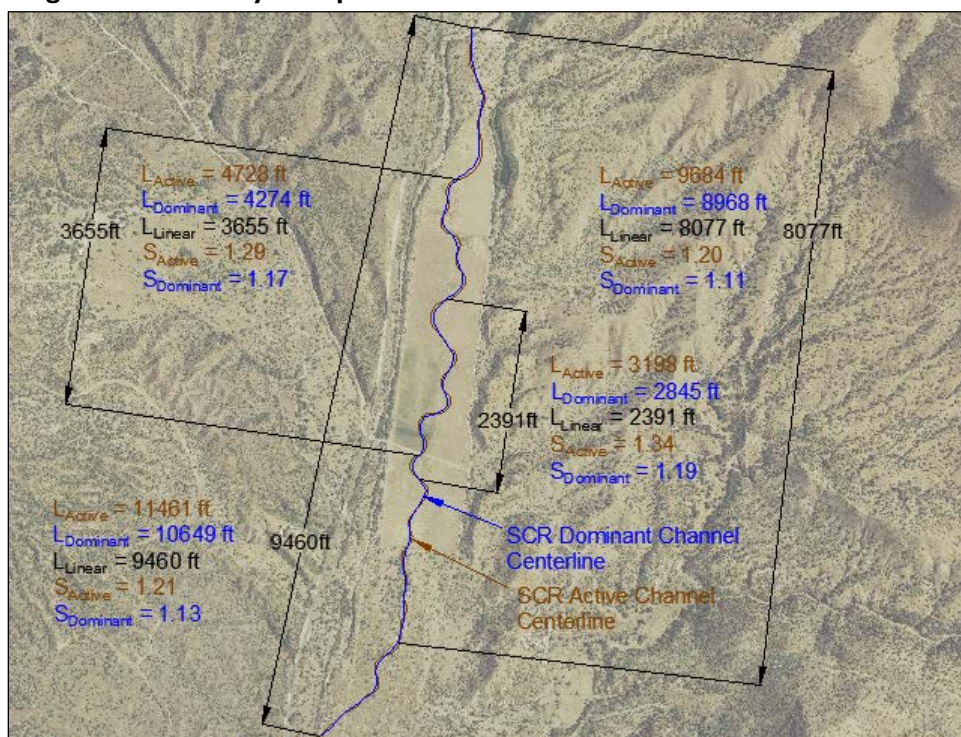
**Figure 12. Sinuosity Comparison of Dominant Channel and Active Channel**

The inundated flow area (i.e., the 5-year flood area and the area for which mitigation acreage was calculated) will have a lower channel sinuosity than the active channel centerline. For instance, that reach of the SCR Channel with a sinuosity of 1.34 as measured from the active channel centerline has a lower dominant sinuosity of 1.19, and the overall measurement of the entire SCR Channel has an active channel sinuosity of 1.21, and a dominant sinuosity of only 1.13 (**Figure 11**). This approach demonstrates that sinuosity was informed by scientific and engineering principles rather than an attempt to maximize mitigation credit.

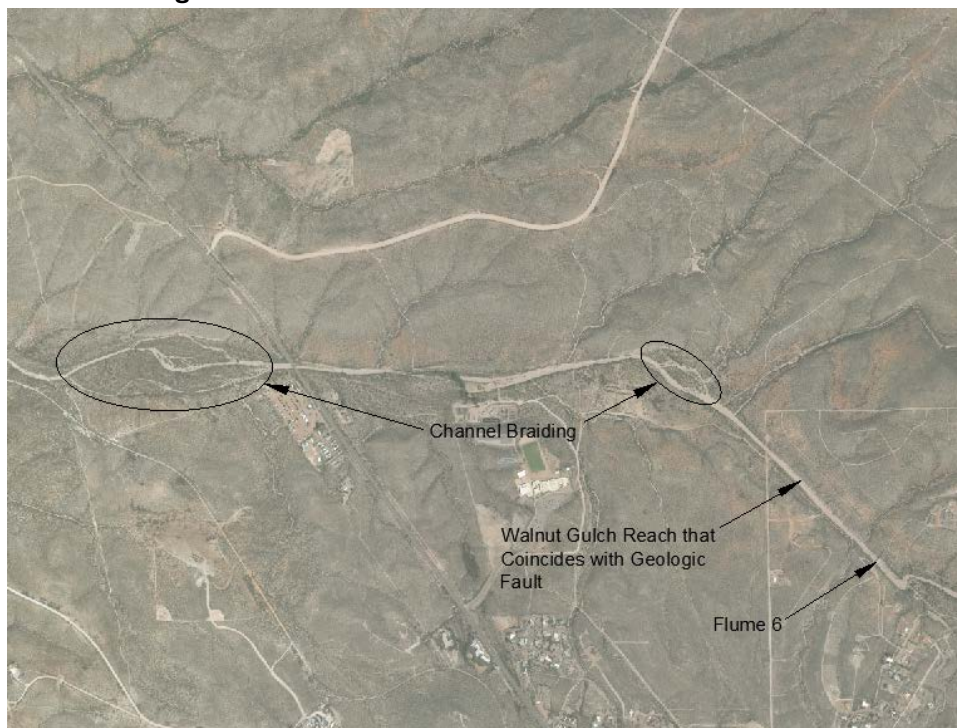
**Figure 13. Walnut Gulch at Flume 6 and Downstream**

The HMMP (Exhibit 1) depicts Walnut Gulch between Flume 2 and Flume 1 as well as downstream of Flume 1, and depicts a tributary to Walnut Gulch at Flume 7. The majority of channel braiding occurs along this reach of Walnut Gulch; this is not the same reach for which hydrologic analyses were conducted and results compared with recurrence intervals and peak flows from the SCR mitigation project. As described in more detail elsewhere, the reach near Flume 6 was identified as most like the SCR design watershed for hydrologic analysis, with its similar watershed area and elevation. However, the reach near Flume 6 at Walnut Gulch has important physical differences from the SCR mitigation project site. Specifically, Walnut Gulch near Flume 6 flows through a narrower valley with more physical constraints that limit channel migration and sinuosity more than the unconstrained physical conditions at Sonoita Creek. The straight reach of channel downstream of Flume 6 is coincident with a geological fault line and is confined by geologic controls, and therefore should not be used as a reference reach for sinuosity to apply to Sonoita Creek. Nevertheless, there is some braiding between Flume 2 and Flume 6 (**Figure 13**).

The occurrence of braiding along Walnut Gulch is more frequent where there is sufficient width of valley floor to accommodate multiple channels. This occurs to some degree downstream of Flume 6, but more significantly downstream of Flume 2, where relatively less confined reaches of Walnut Gulch are more physically similar to the conditions at Sonoita Creek (despite having a larger watershed area) than the reach near Flume 6. When analyzing channel form, the physical/geomorphological conditions in the reach from Flume 2 downstream to Flume 1 better represent Sonoita Creek than upstream at Flume 6, and are thus more representative of the channel form that is expected for the Sonoita Creek project area.

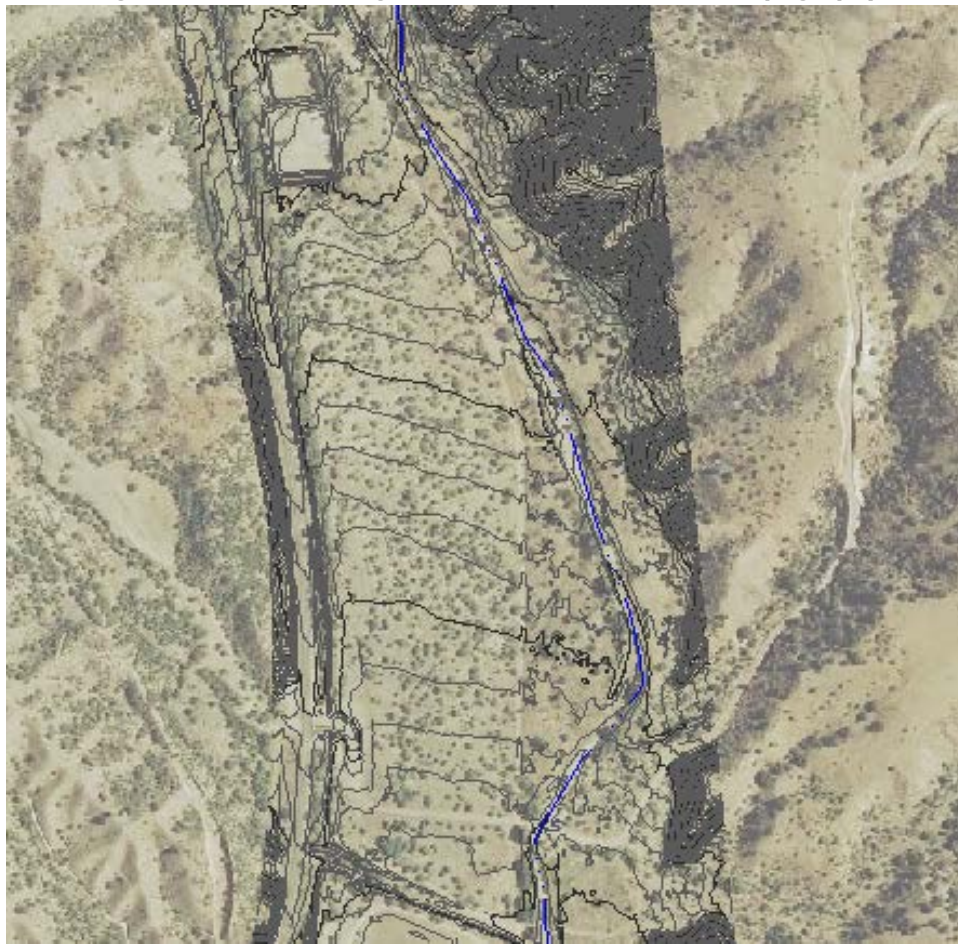
**Figure 14. RX Ranch Agriculture Field and Leveled Topography**

At RX Ranch, clearly the valley bottom has undergone leveling activities and periodic cultivation. The parallel lines of topography at RX Ranch demonstrate the unnaturally uniform landform in this reach of the valley (**Figure 14**). There is considerable evidence of diversions and manipulation to Sonoita Creek at RX Ranch (**Section 2.3**). Currently, Sonoita Creek at RX Ranch is a straight reach with a single bend located on the east edge of the agricultural field. There is sufficient area within the agricultural field to reestablish Sonoita Creek and create a more sinuous, functional stream.

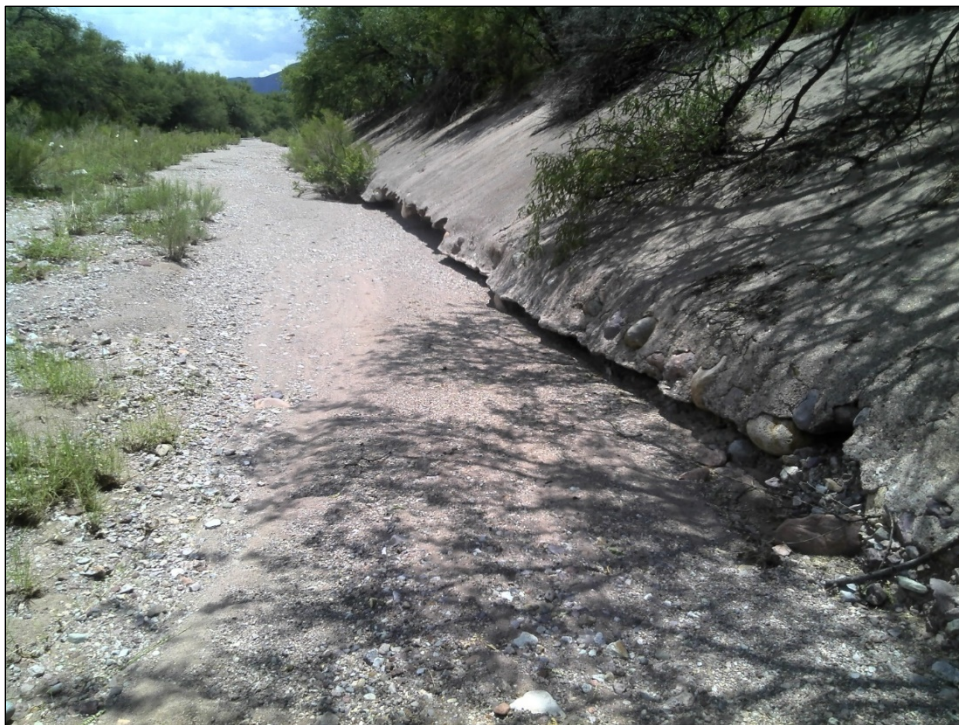
**Photo 2. Facing Downstream in Sonoita Creek at SCR with Concrete West Bank**

The HMMP extensively details the reasons to reestablish Sonoita Creek to a central position in the valley. The present-day location and layout of Sonoita Creek at SCR on the western edge of the valley is a result of a historic realignment and straightening to accommodate agricultural and infrastructure development, and may well be the remnants or alignment of a 19<sup>th</sup>-century irrigation ditch (see historical discussion in **Section 2.3**). Sonoita Creek is artificially constrained between the highway and a gas pipeline; this location exacerbates erosion and incision while precluding the development of even minor amounts of channel complexity and an irregular meander pattern found in natural settings as described by the EPA (2017). The Sonoita Creek reaches at RX Ranch and SCR Ranch show clear and extensive evidence of manipulation and include multiple hydraulic structures (concrete channel walls, gabion baskets, car bodies, etc.) designed to armor channel banks and prevent channel migration (**Photos 2 and 3**). These hardened bank structures increase flood velocities, prevent establishment of riparian species and establishment of a functional floodplain, and reduces channel complexity (Florsheim, Mount, and Chin 2008).

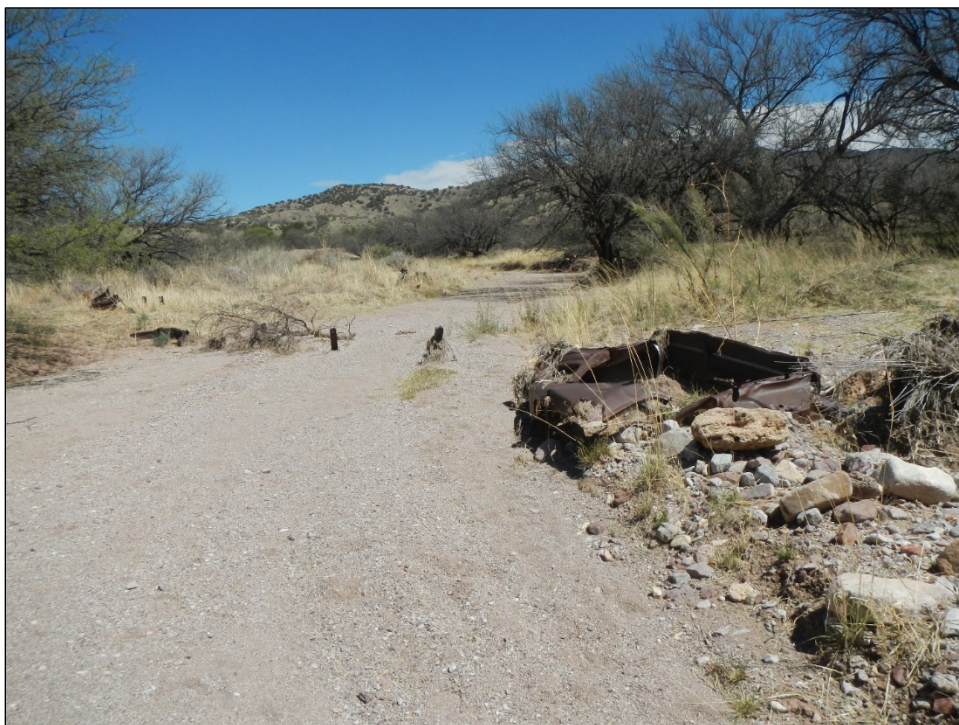
**Photo 3. Car Body and other Historic Hydraulic Structures**

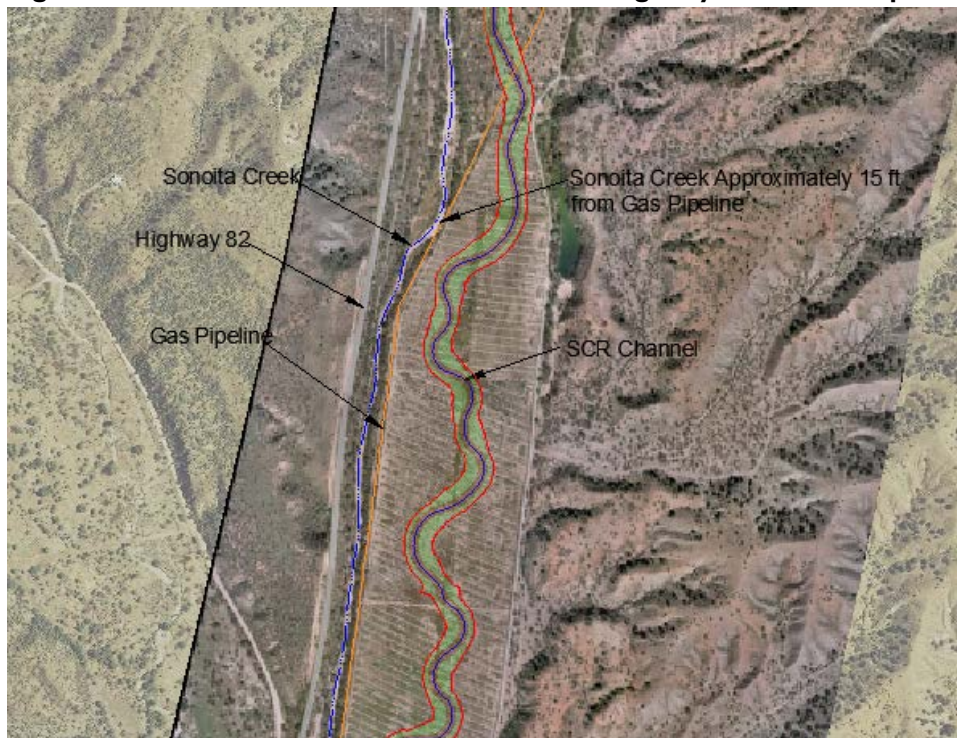
**Figure 15. Sonoita Creek Constrained Between Highway 82 and Gas Pipeline**

This approach is not feasible at SCR because the gas pipeline is parallel to and in close proximity to the current eastern channel bank, in one case as close as about 15 feet (**Figure 15**). Furthermore, rehabilitating only the eastern bank would still leave in place the existing west bank, constrained by the highway and significantly manipulated and degraded by concrete channel walls and gabion baskets. The majority of the artificial armoring, which precludes channel migration or development as well as access to a functional floodplain, is located at the existing west bank at SCR.

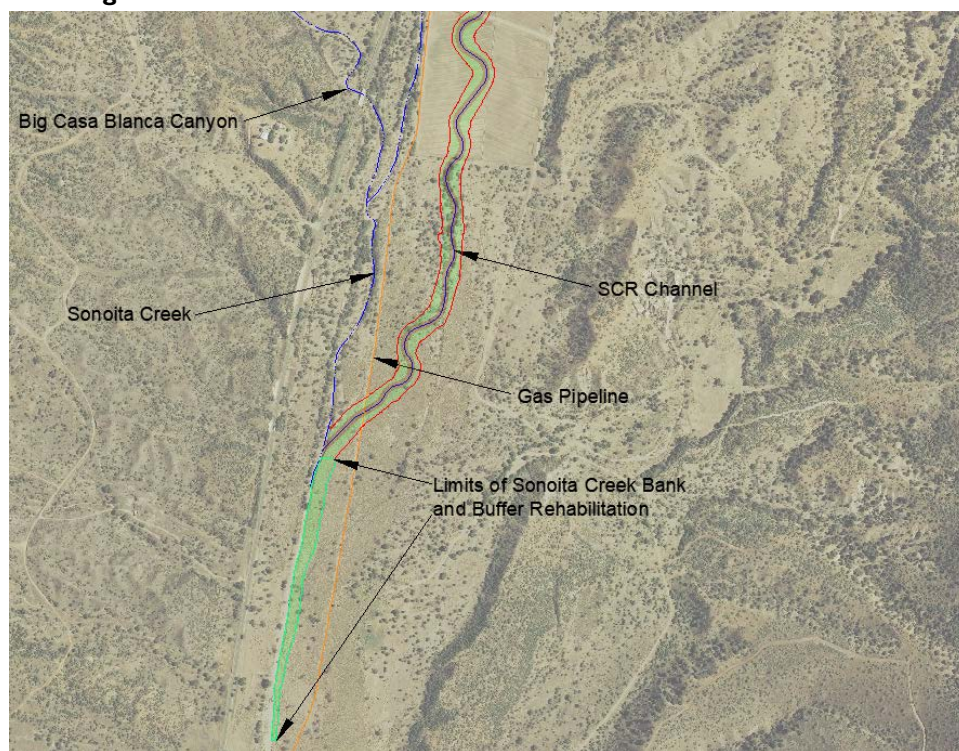
**Figure 16. Bank and Buffer Rehabilitation at Lower Sonoita Creek**

This comment is notable in that it directly contradicts the EPA's comment in the immediate preceding paragraph, wherein they recommend rehabilitation along the eastern bank of the existing Sonoita Creek. Bank and buffer rehabilitation along the eastern bank is not practical for Sonoita Creek throughout the majority of SCR because there is not enough space between Sonoita Creek and the gas pipeline. However, bank and buffer rehabilitation is feasible along lower Sonoita Creek (as opposed to backfilling and replacing Sonoita Creek) because there is sufficient space, generally 330 to 350 feet, between lower Sonoita Creek and the gas pipeline (**Figure 16**).

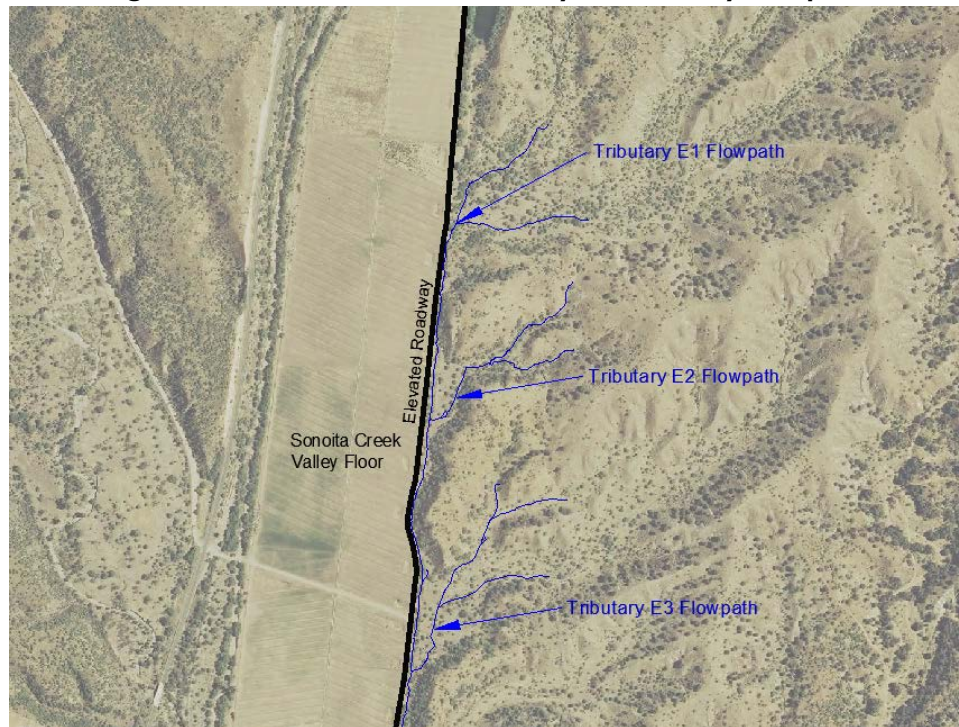
**Figure 17. Effect of Elevated Roadway on Tributary Flowpaths**

The EPA (2017) finally states that there is not sufficient stream power to form a permanent bed and bank channel for the three tributaries. A defined bed is already observed where the roadway interrupts natural flow and diverts stormwater south along the road fill, and there are defined beds for each tributary upstream of the area where they currently terminate. It is speculative to suggest that the channel bed and bank features of the three reestablished connections to Sonoita Creek will recede over the long-term. Even if they do, eliminating the elevated roadway will reestablish the natural drainage pattern for stormwater and sediment to enter the Sonoita Creek valley with associated ecological benefits.

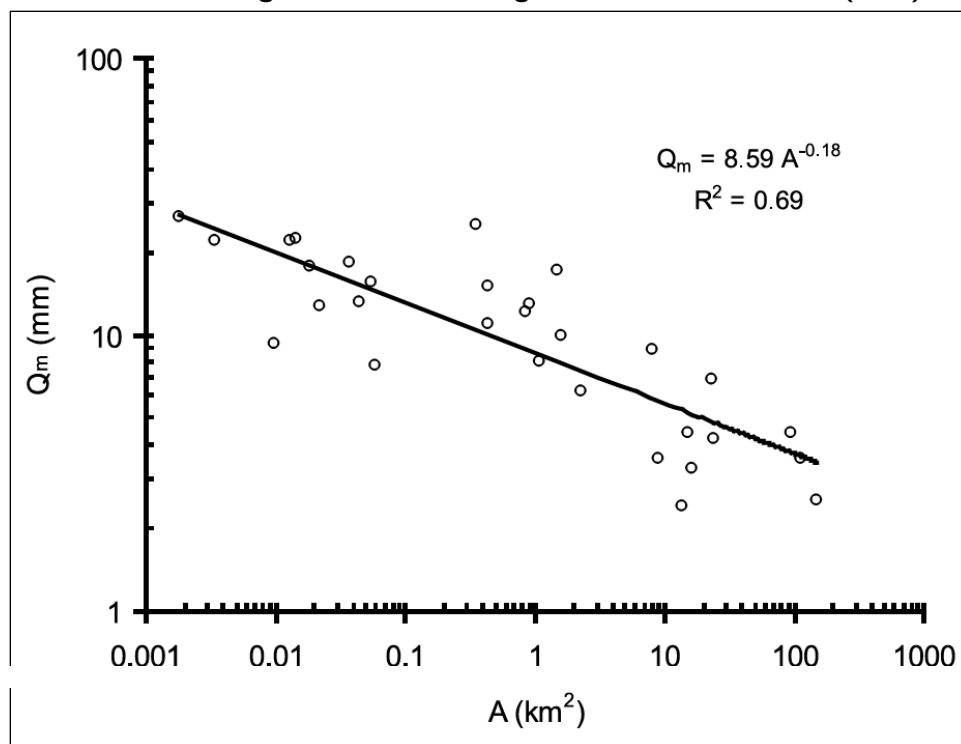
**Exhibit 5. Average-Annual Runoff Regression from Stone et al. (2008)**

Note: The equation depicted in the preceding figure for average-annual runoff per unit area is:  $Q_m = 8.59A^{-0.18}$ , where the units of runoff ( $Q_m$ ) are average depth in millimeters per unit area (square kilometer), and the units of area ( $A$ ) are in square kilometers.

In English units, the equation in **Exhibit 5** is:  $Q_{AFA} = 15.20A^{-0.18}$ , where  $Q_{AFA}$  is the annual runoff in acre-feet per unit area (square mile), and  $A$  is the watershed area in square miles. Assuming  $A = 14$  square miles (the total size of the Rosemont watershed at the USGS SR 83 streamgage, not subtracting areas reporting to stock ponds) the resulting value of AFA per square mile, in English units, is:  $Q_{AFA}$

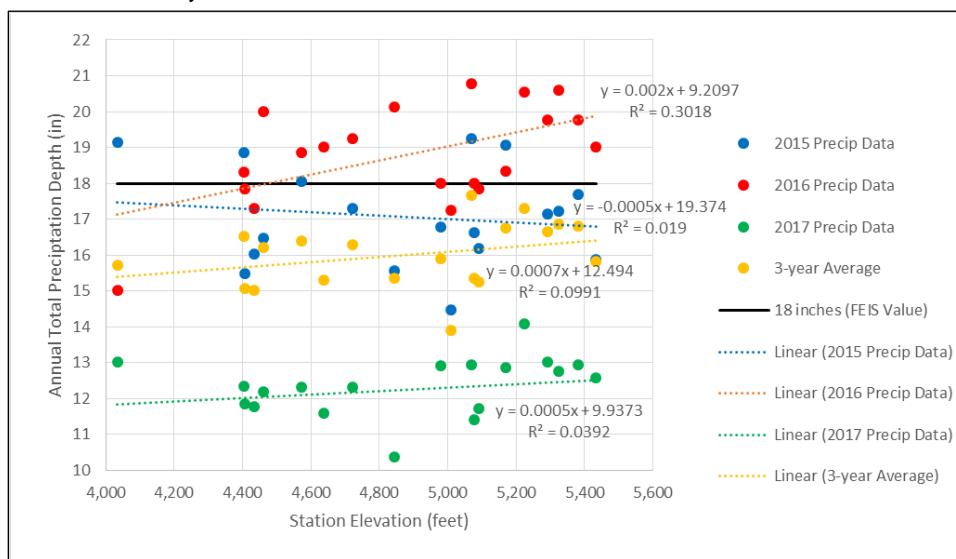
**Exhibit 6. Three (3) Year Total Annual Precipitation Variability across the Rosemont Project Watershed**

represent any meaningful relationship); (3) there is high variability in total annual precipitation across the watershed (e.g., in several cases, gages at lower elevations had higher precipitation values than gages at higher elevations); and (4) the average value of 18 inches (used in the FEIS) is representative, and likely a conservative estimate, for the site-wide average. Thus, the average-annual rainfall value of 18 inches is valid and representative for the entire Rosemont Project watershed.
